SECTION 3 EMERGENCY PROCEDURES

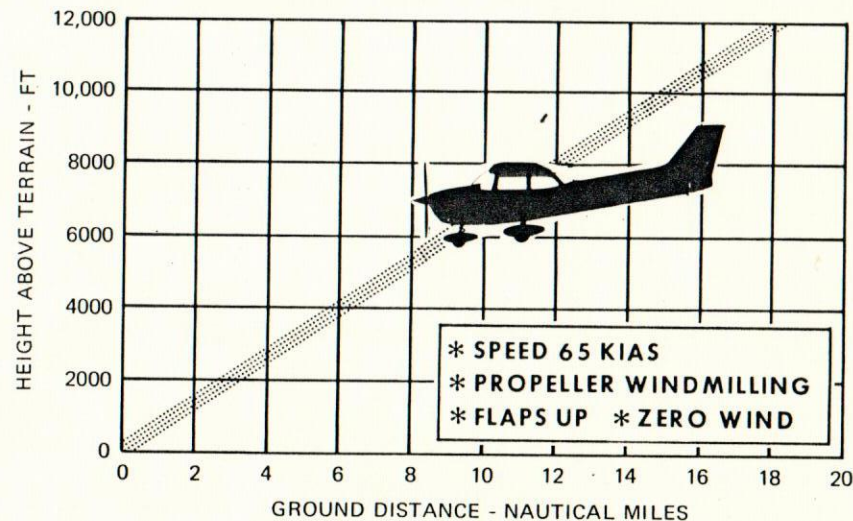
Figure 3-1. Maximum Glide

After an engine failure in flight, the best glide speed as shown in Figure 3-1 should be established as quickly as possible. While gliding toward a suitable landing area, an effort should be made to identify the cause of the failure. If time permits, an engine restart should be attempted as shown in the checklist. If the engine cannot be restarted, a forced landing without power must be completed.
